Forgotten Treasure

Once-hidden mural restored to 1941 beauty // By Tuan Vo

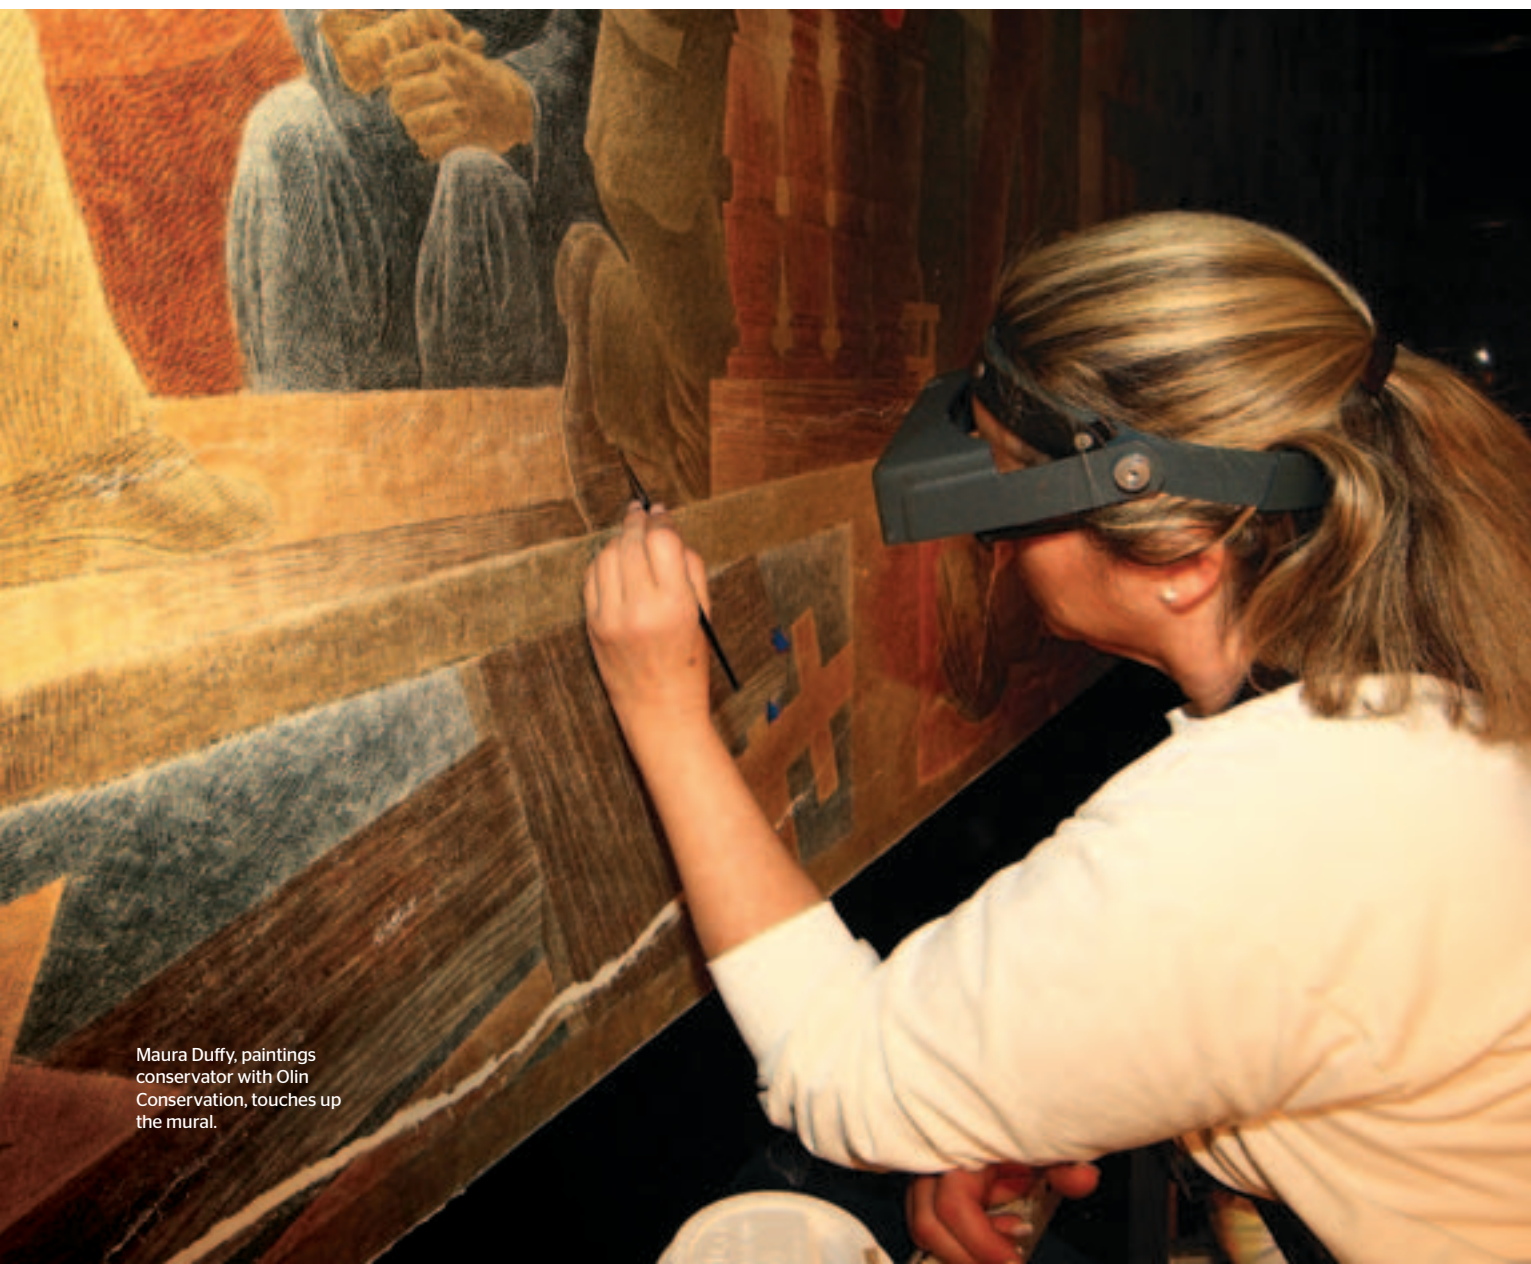
Maura Duffy, paintings conservator with Olin Conservation, touches up the mural.

Olin Conservation, Inc., which is undertaking the conservation of the mural with funding from the General Services Administration, said that building structure fatigue and fluctuations in humidity and temperature had caused cracks in several places, and the plywood covering placed over the mural in 1954 left holes in its surface. When the painting was uncovered and restored in 1977, further damage was caused by the restoration artists, who used oil paint over the original water-based paint. Over time, incorrect light fixtures may have faded the mural.

Restoration work is a delicate and detailed process. First, the conservator examines the mural with enhanced lighting, including ultraviolet lights, and magnification. Small and discrete solvent tests determine the solubility of the original paint and surface, which helps identify the cleaning methods to use.

Repairing and filling up cracks is a major undertaking. First, the crack is cleaned, and then an acrylic resin is carefully injected using syringes and pipettes. To repair the damage from the use of oil-based paint, Olin Conservation removed the old paint and then touched up the area with an “inpainting” technique. Synthetic resin paint made especially for art restoration was used since it doesn’t bond to or damage the original painting and can be removed later if needed.

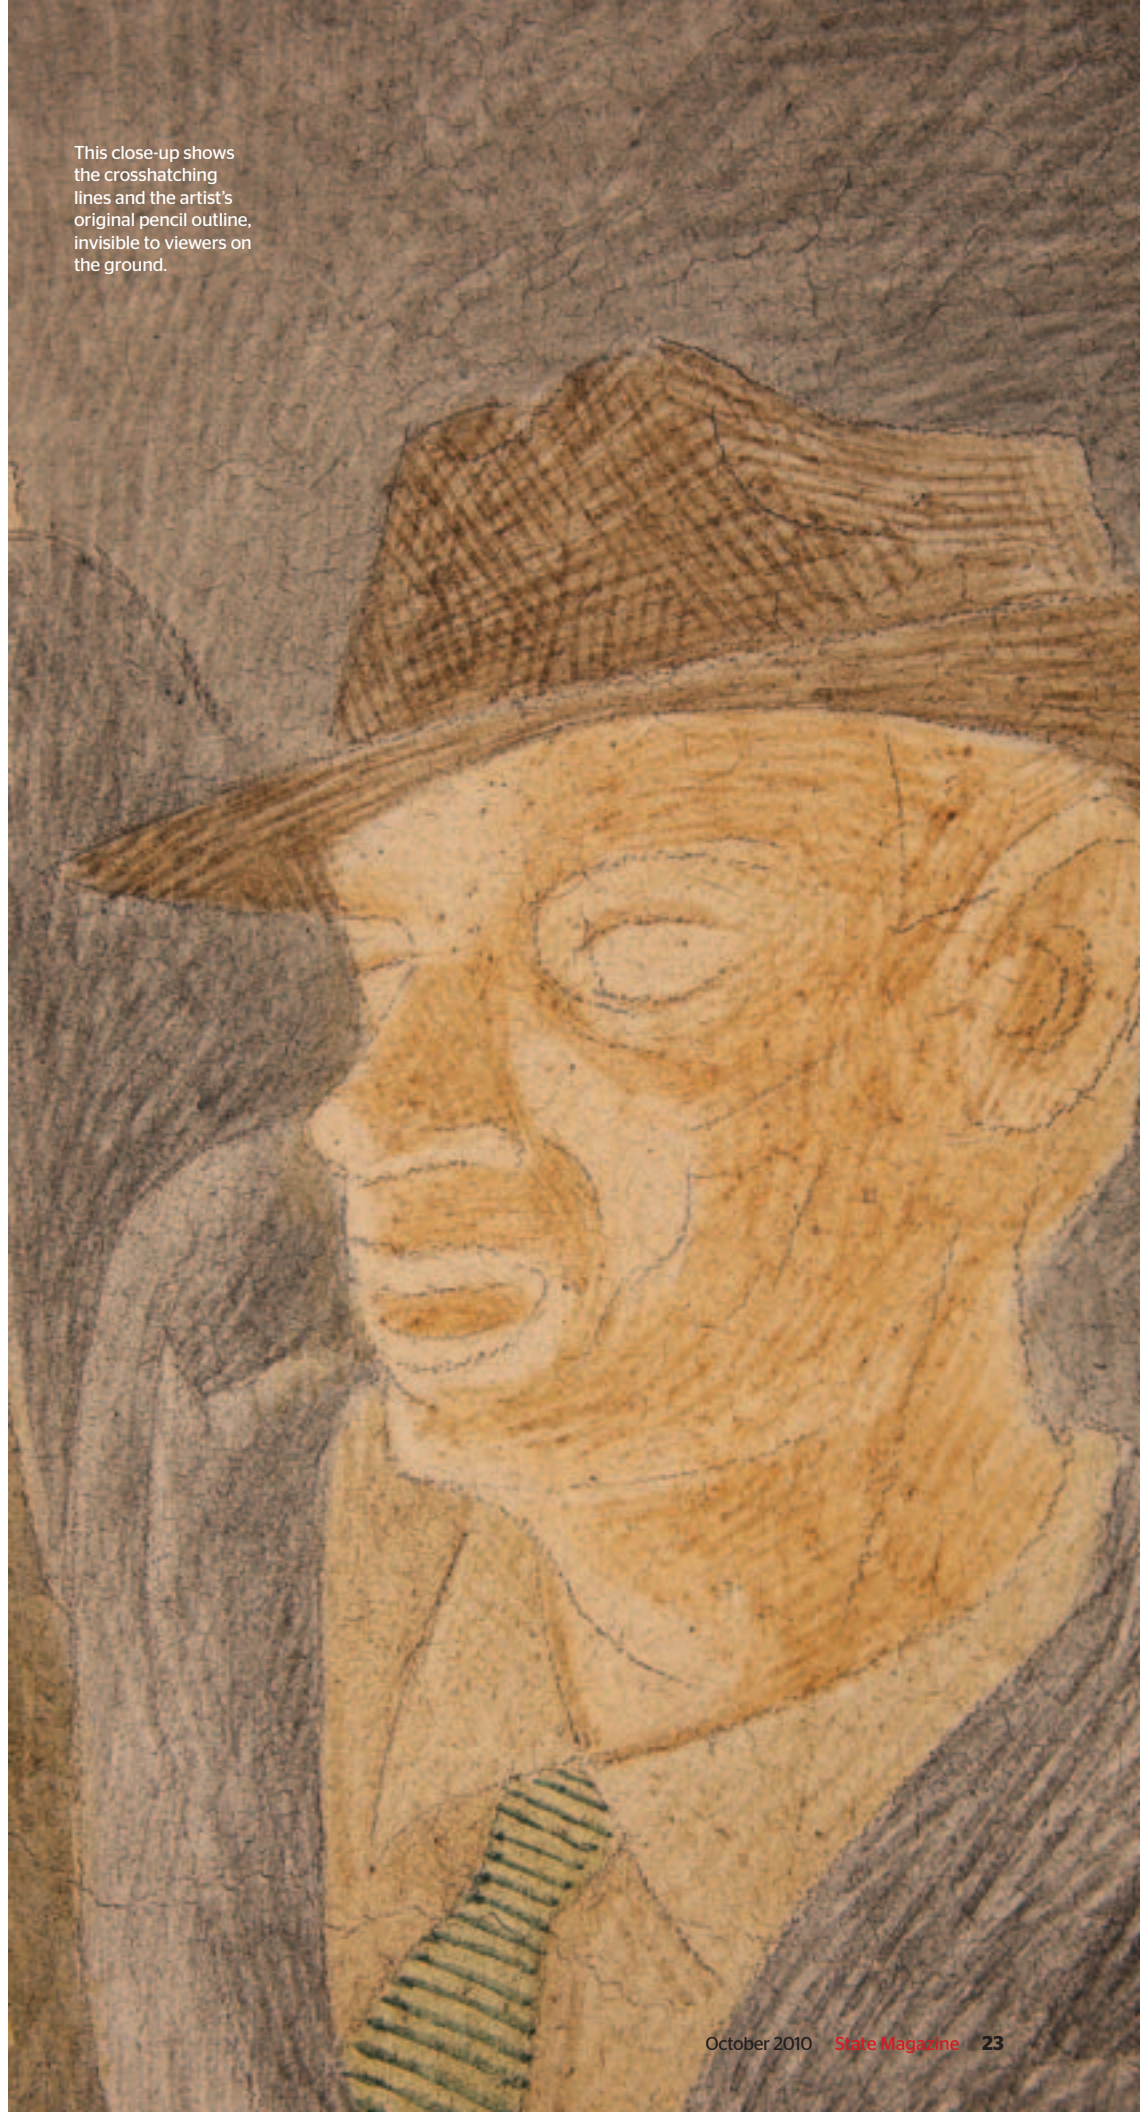
The mural was painted with water-based paint on dry plaster in the crosshatching style, which originated in the Middle Ages and was popular for Italian church paintings during the Renaissance. More recently, the style can be found in cartoon drawings. Close up, the artist's original pencil outline of the mural is clearly visible after seven decades.

This close-up shows the crosshatching lines and the artist’s original pencil outline, invisible to viewers on the ground.
